# Manhole Inspection Summary

Manhole # S33EE\_035MH

Insp Date: **2/21/07 9:56 AM**

**Location** Address: **5 PRESTON ST**

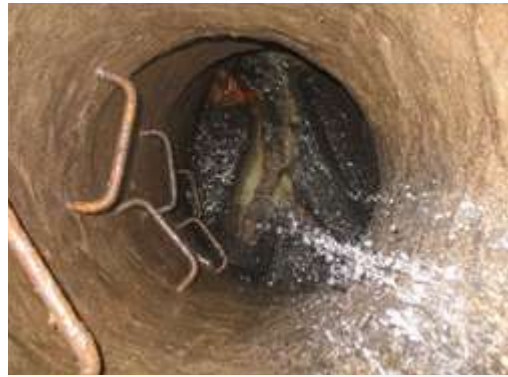
Top View

Corroded steps. Bench debris.

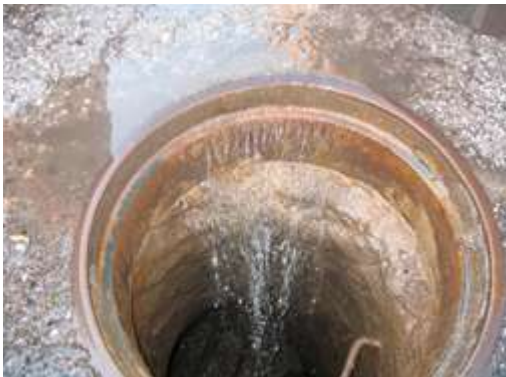
Defect

Large amount of water entering the MH.

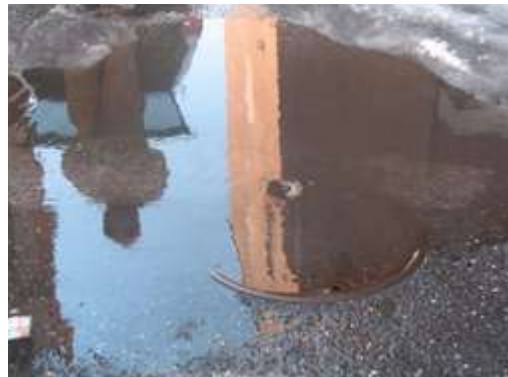
Defect

Ponding.

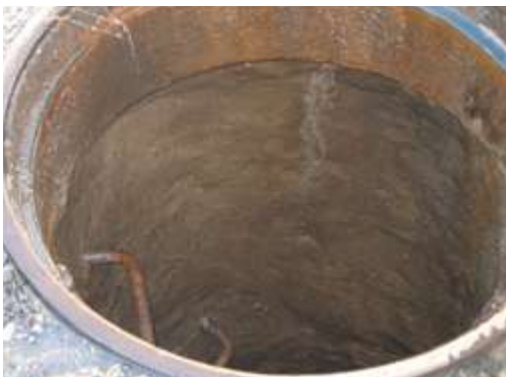
Defect

Frame leaks. Corbel infiltration.

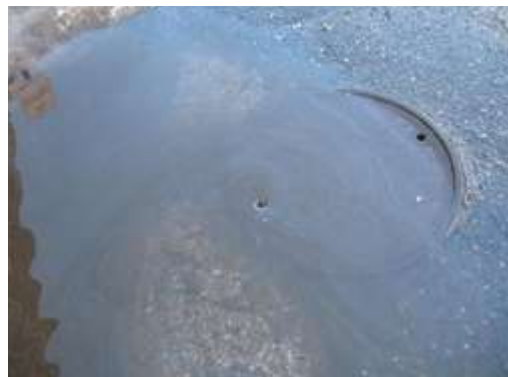
Defect

Ponding.

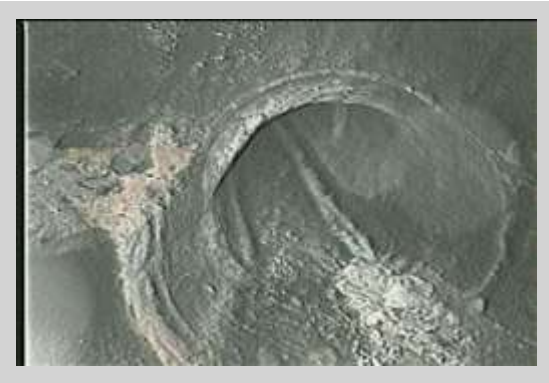
### 16 in. Circular Gravity Sewer Pipe Out @ 12 O'Clock

Deposits: ☐ None ☐ Mud ☐ Sludge ☐ Debris ☒ Grease

Silt Depth: **0** (in.) Deposits Extent: **Light**

Infiltration: **Evidence** Pipe Seal Cond: **Unknown**

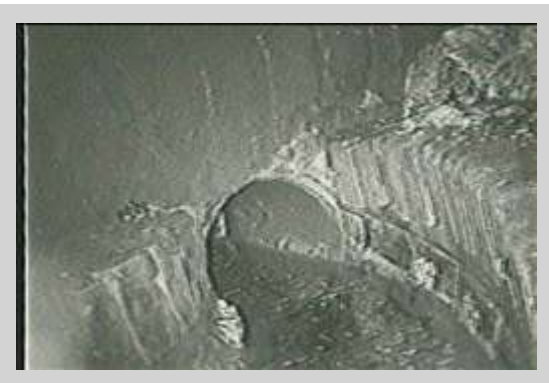
### 8 in. Circular Gravity Sewer Pipe In @ 3 O'Clock

Deposits: ☐ None ☒ Mud ☐ Sludge ☒ Debris ☐ Grease

Silt Depth: **0.5** (in.) Deposits Extent: **Light**
